FACILITY COMPLIANCE INSPECTION REPORT

Division of Waste Management Solid Waste Section

Fogleman and Fogleman Landfill and Recycling Facility – LCID Landfill and Processing Facility
 4005 Intermere Road
 Durham, NC 27704

Comprehensive Inspection

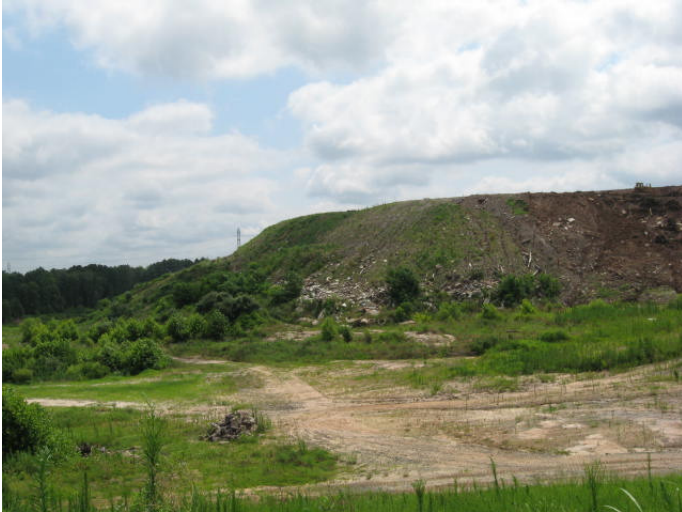
West side slope/left rear of landfill
(inert debris to cover with soil)

26. Ensure the area of inert debris deposited on the west side slope/left rear is adequately covered with soil.
27. The landfill cap contains vegetative material. Vegetative material should be routinely mowed.

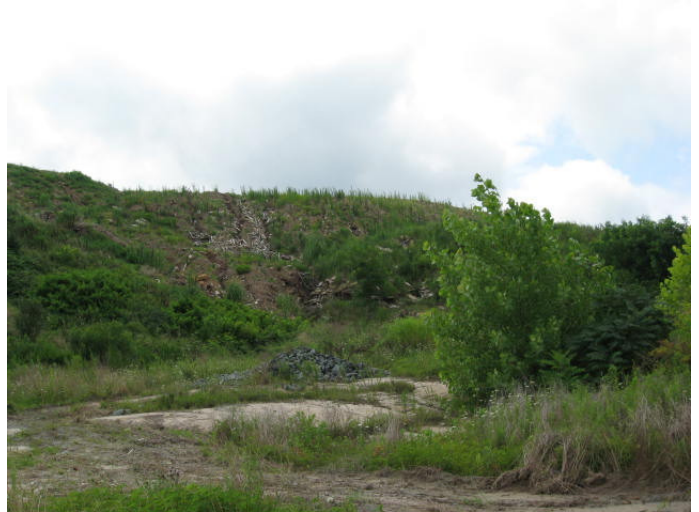
North side slope/rear of landfill (erosion rill to repair
and LCD to cover with soil)

24. The erosion rill on the north side slope/rear of the landfill shall be repaired and LCD adequately covered with soil.
25. The area of exposed LCD on the east side slope/right rear of the landfill shall be adequately covered with soil.

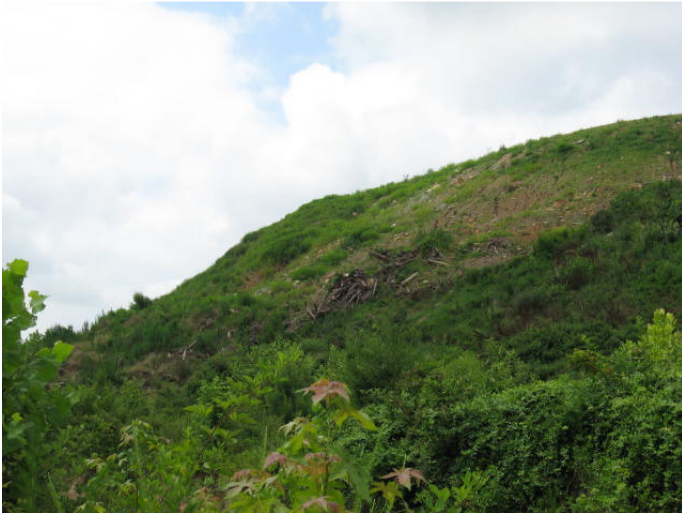
East side slope/right rear of landfill
(LCD to cover with soil)

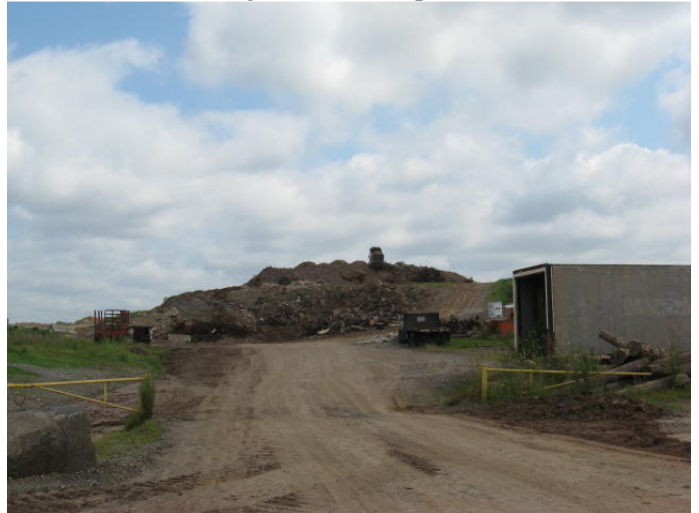
South side slope/front of landfill (current working face
stored firewood logs at toe of slope)

34. The facility sorts-out logs for firewood. Firewood logs are brought to the toe of the south slope/front of landfill. Mr. Fogleman stated that the firewood logs are routinely removed (third party hauls-off to cut/chop and sell). It is recommended that an adequate fire break be maintained between landfill operations and stored firewood logs.
